AIRCRAFT ACCIDENT INVESTIGATION REPORT

Japan Air Lines Co., Ltd.
Boeing 747 SR-100, JA8119
Gunma Prefecture, Japan
August 12, 1985

Aircraft Accident Investigation Commission
Ministry of Transport

June 19, 1987

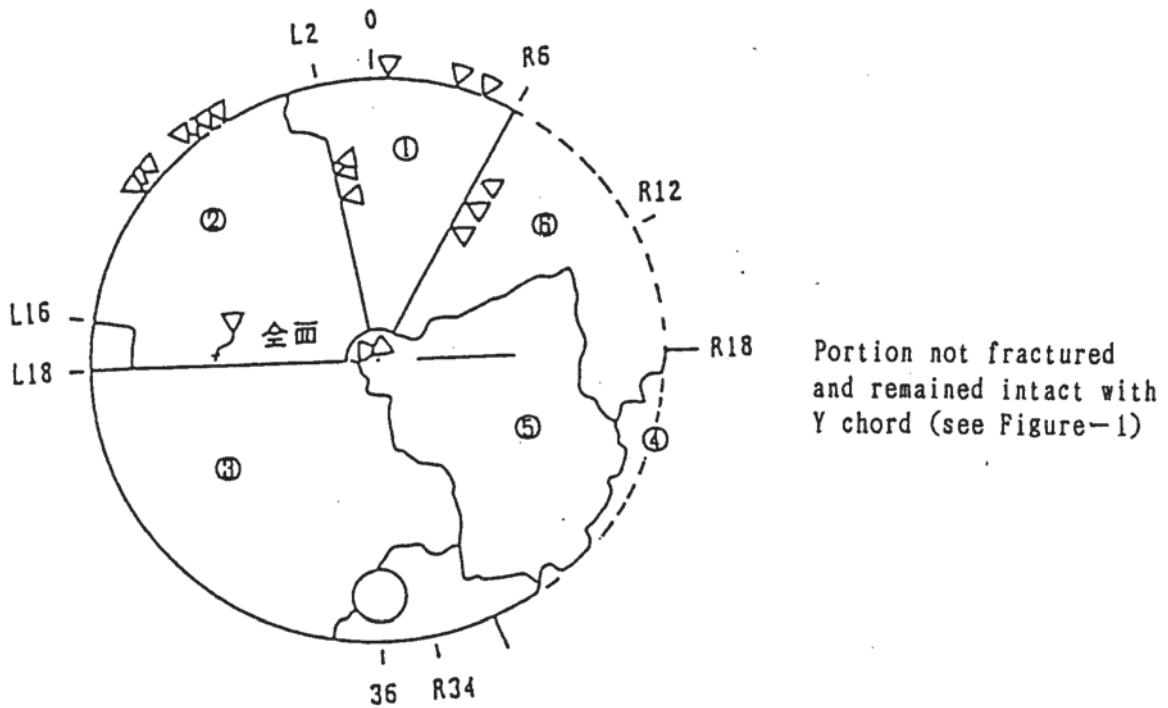
Figure-6 Major Fracture Lines

Major fracture lines, indicate points observed by electron microscope, as viewed from aft of the pressure bulkhead.

(a) Fracture of webs along L18 stiffener

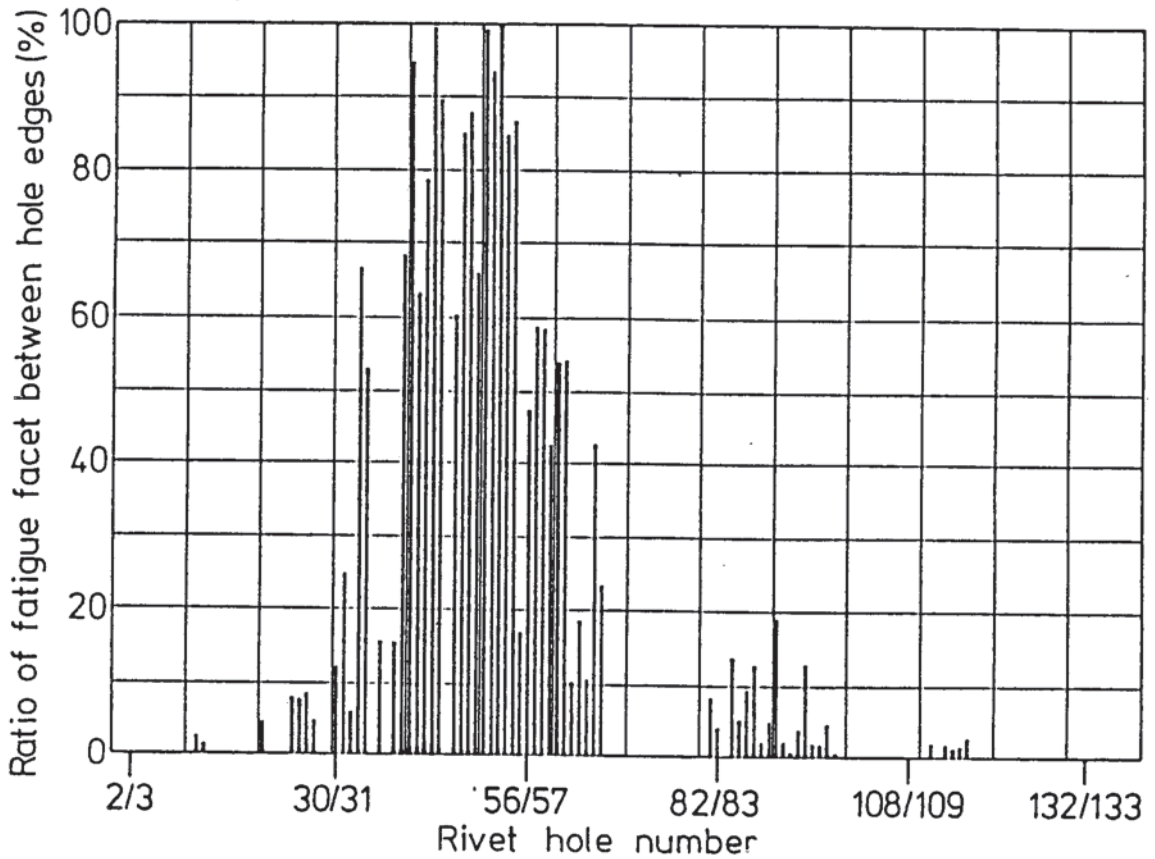
Figure-7 Distribution of Fatigue Failure Ratios between Hole Edges

Ratios of fatigue failure between the hole edges, when shown in a bar chart, are varying along stiffener L18 as in Figure-7 below.

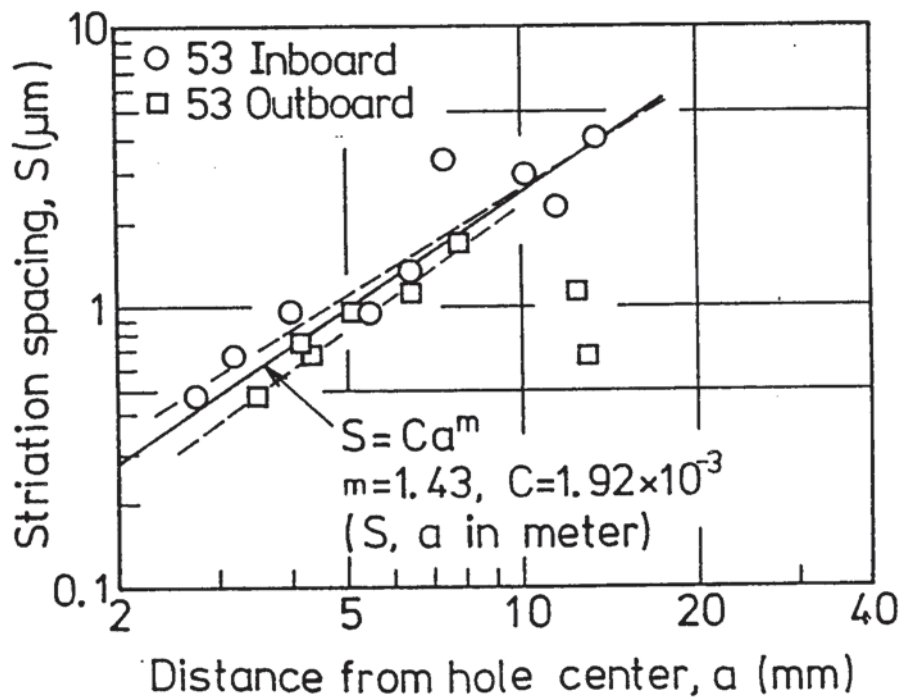
Figure-8 Variation in Striation Intervals
(53rd rivet)

Relationship between the distance from the hole center (a) and the striation spacing (s) is shown in Figure-8, taking as an example rivet hole 53 where striation was clearly observed from a scanning electron microscopic observation on the fatigue fracture surface.

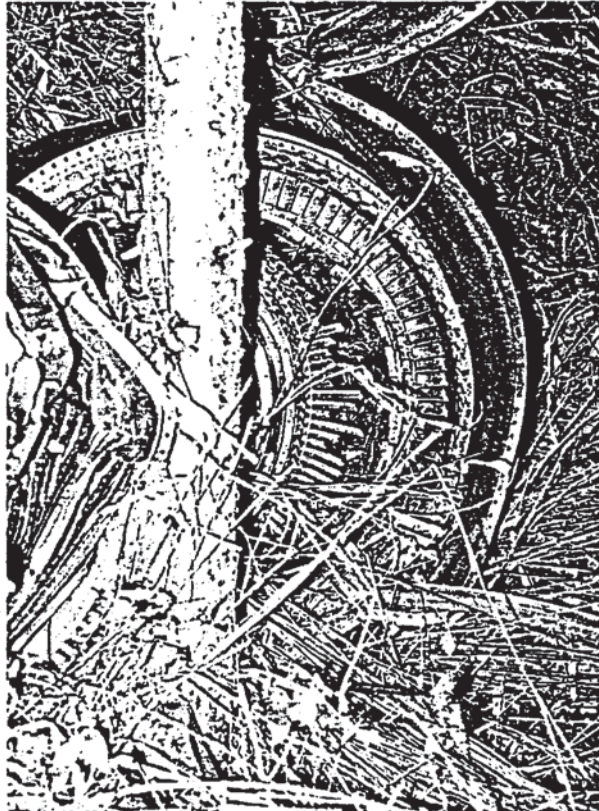
10 Part of No.4 engine

(4) The fan section and core of No.4 engine were destroyed, the fan and the high pressure compressor shaft being severed, and broken into two in the vicinity of stage 9 of the high pressure compressor. The spinner, fan blades, fan case, thrust reverser, engine mounts, gear boxes, combustion chamber, high and low pressure turbine blades, turbine sleeve and plug were torn off and separated (see Photo-10).

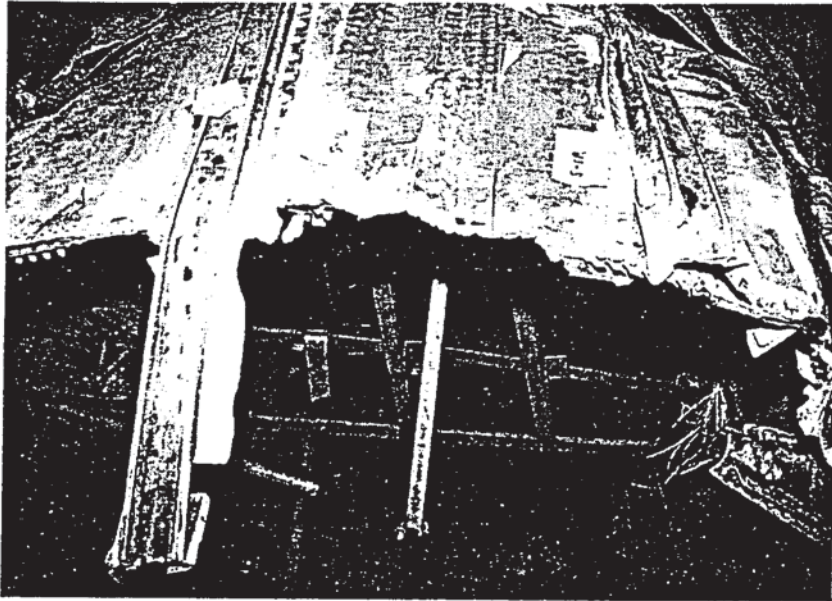
(a) Between fuselage stringer 1L (hereinafter stringers are represented by abbreviation only, where L indicates left side, and R right side) and 1R, the forward angle, doubler, and forward fuselage skin were all fractured on fastener row ① (see Photo-33).

33 Rupture of BS2658 APU firewall
installation parts between SIL and SIR

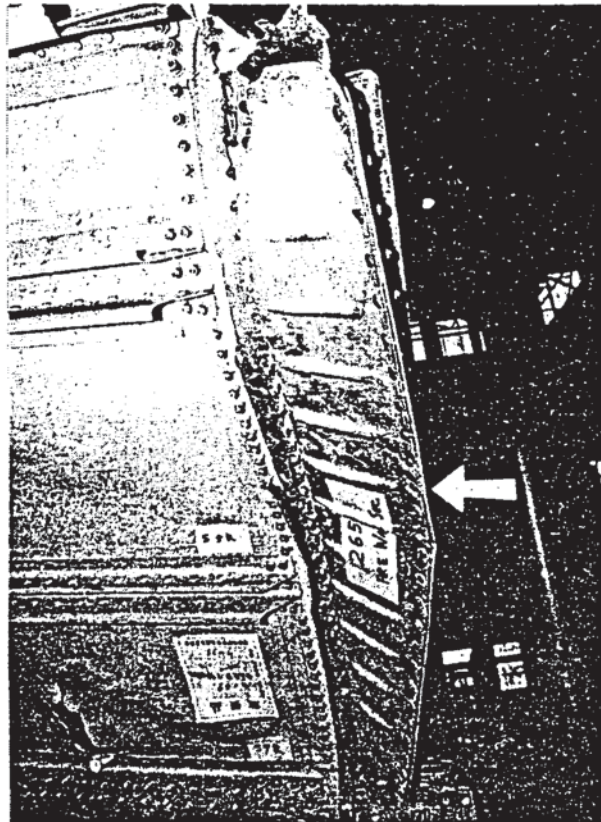
34 Hinge support channel of APU air intake duct

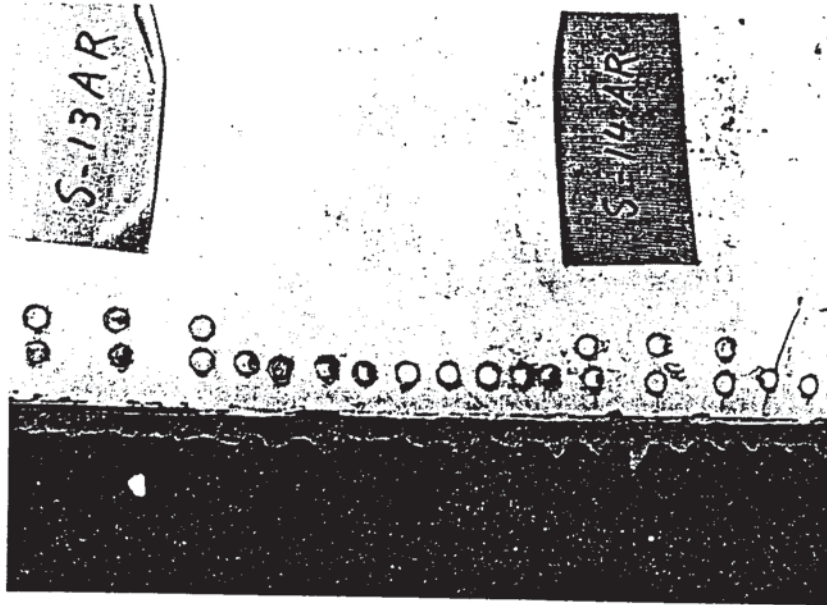
35 Damage of APU firewall installation section at
BS2658 near S14AR

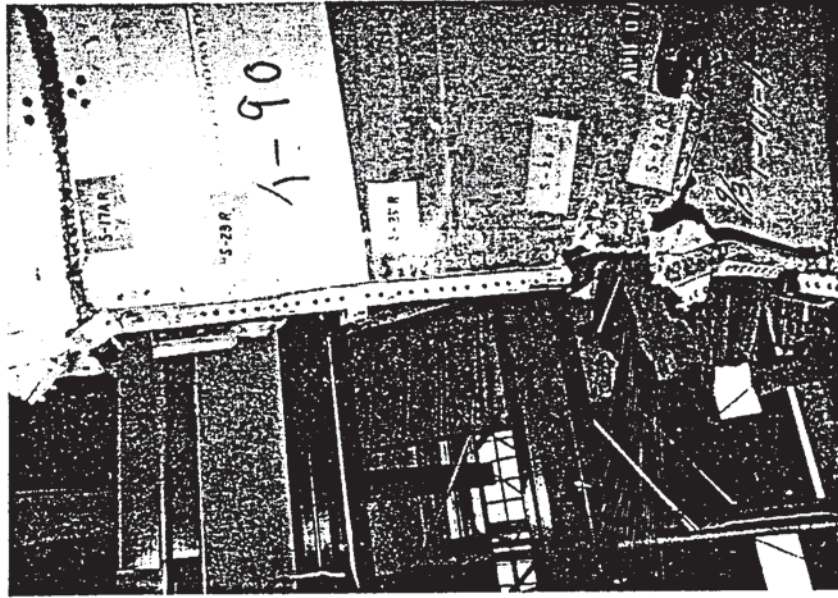
36 Damage of APU firewall installation section at
BS2658 near S23R

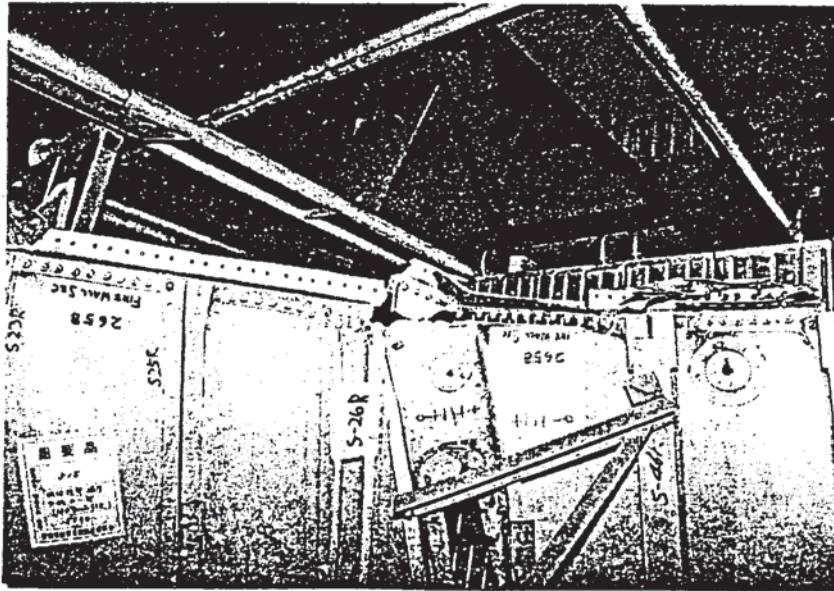
37 Damage of APU firewall installation section at BS2658 near S25R

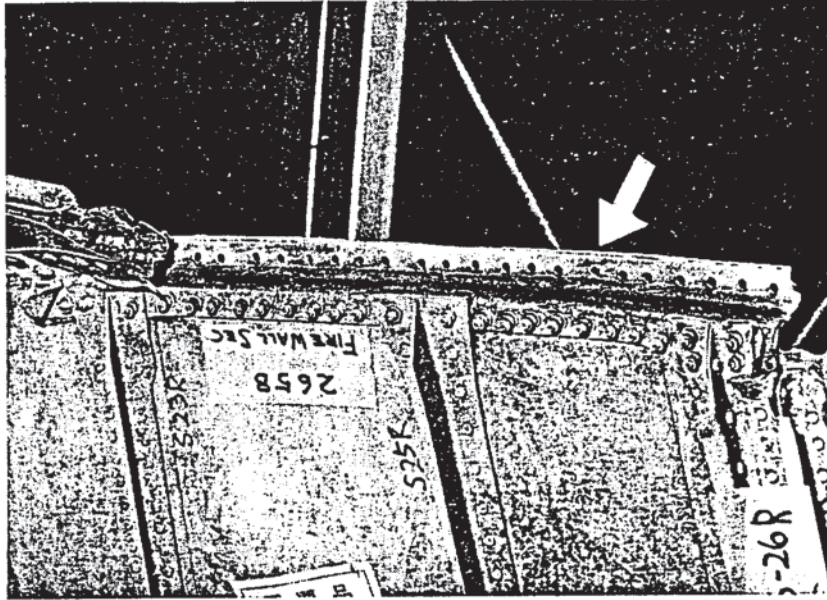
38 Warped doubler in APU firewall installation section at BS2658 near S25R

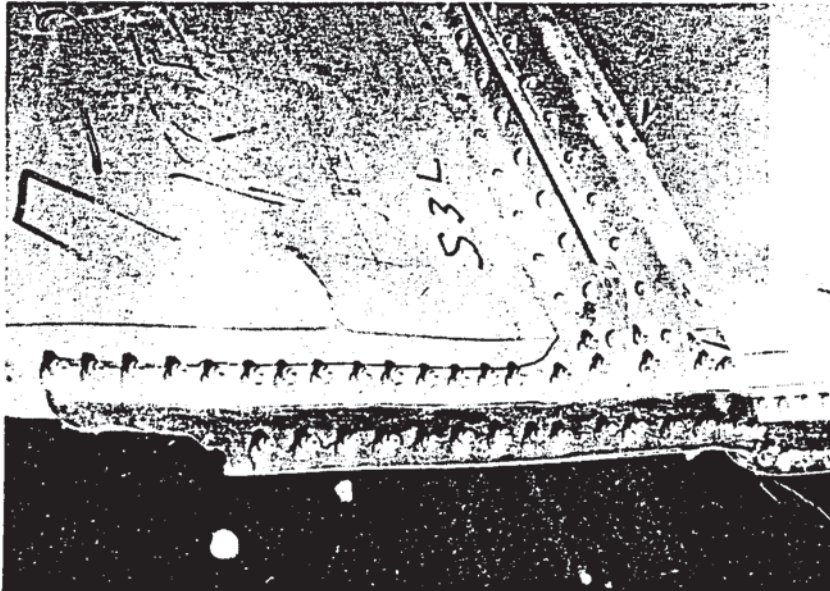
39 Damage of APU firewall installation section at
BS2658 near S3L

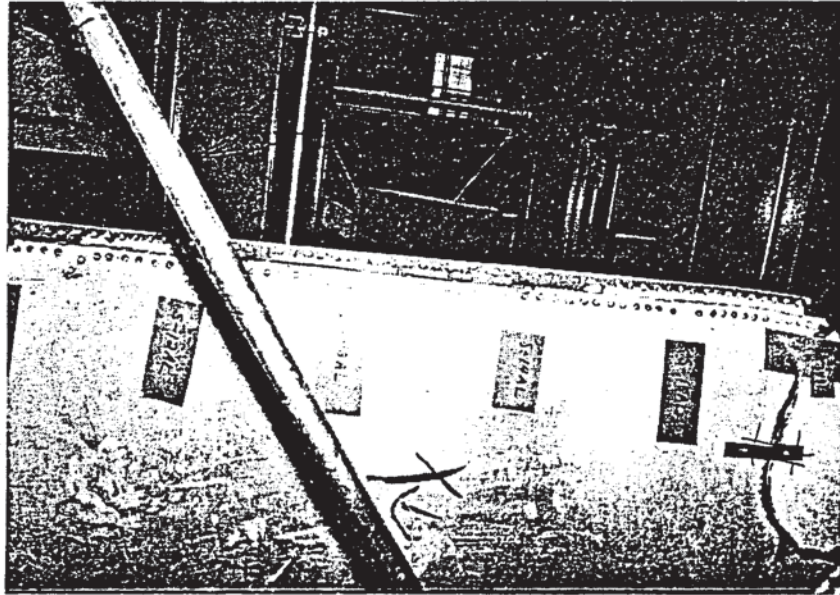
40 Damage of APU firewall installation section at
BS2658 near S14AL

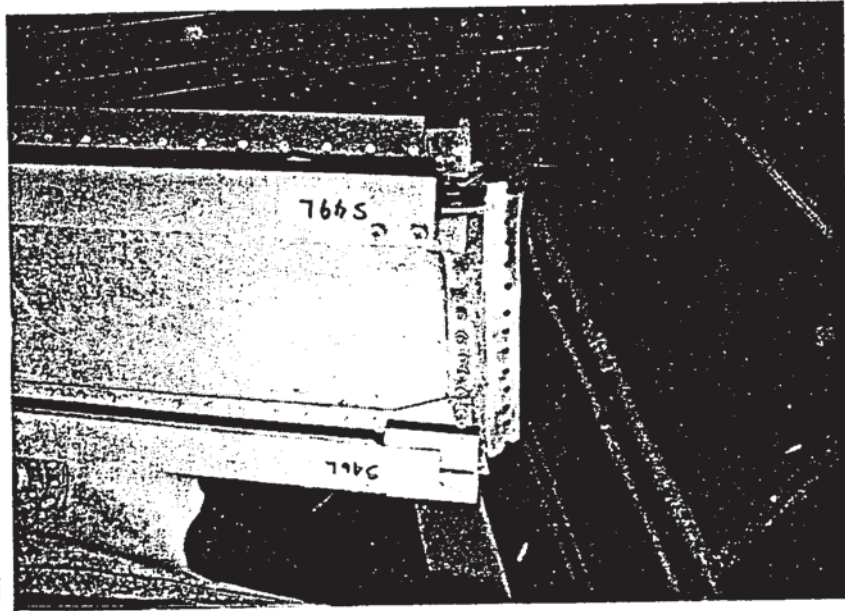
42 Damage of APU firewall installation section at
BS2658 between S46L and S49L

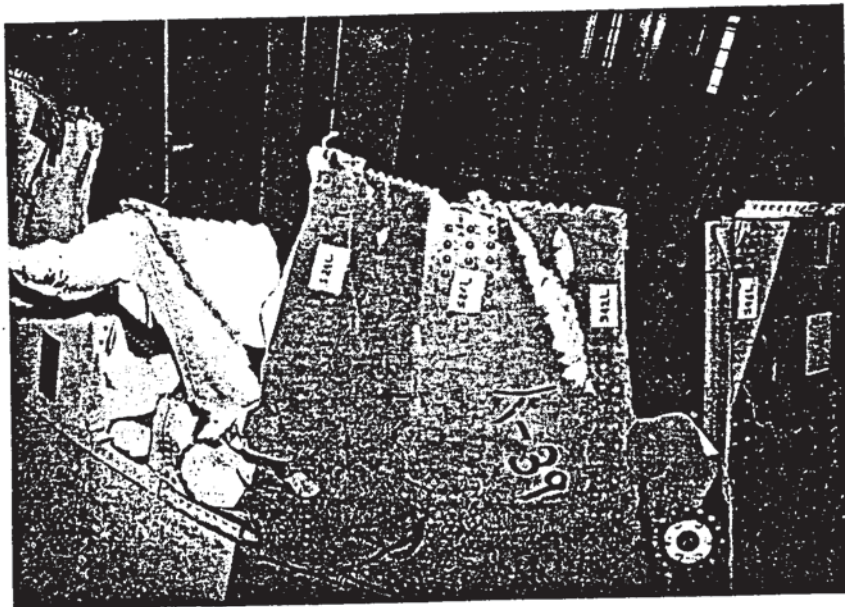
41 Damage of APU firewall installation section at
BS2658 near S26L

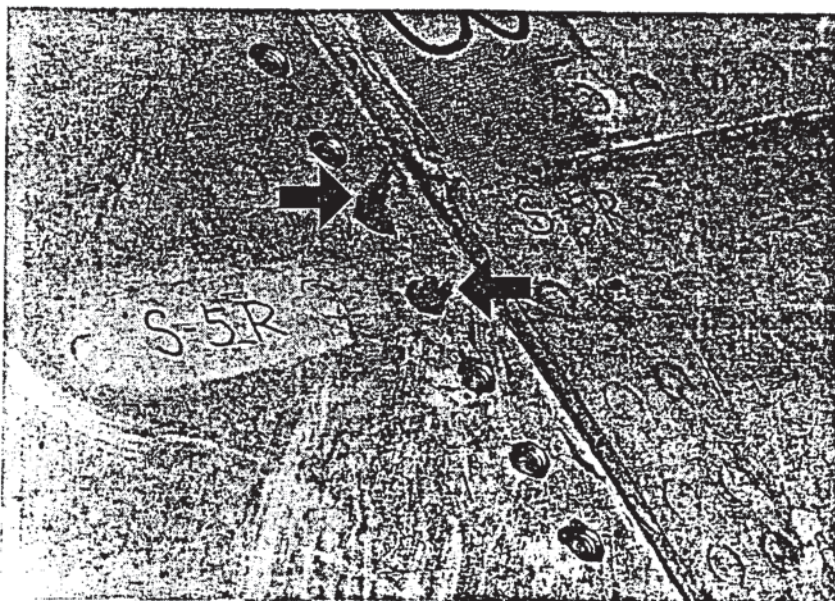
43 Insulation materials that appear to have blown through fastener holes in fuselage skin at BS2638

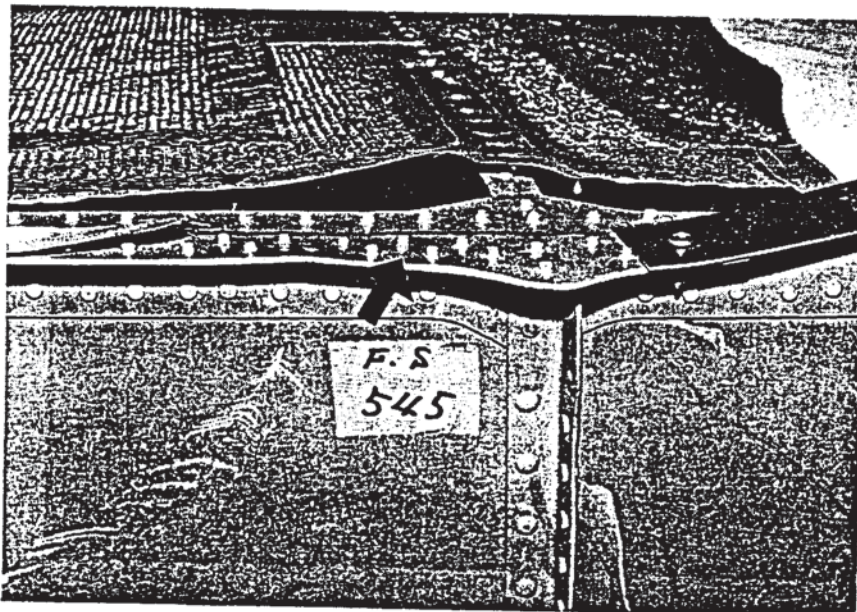
45 Fractured rivets at vertical stabilizer
forward torque box front spar left chord

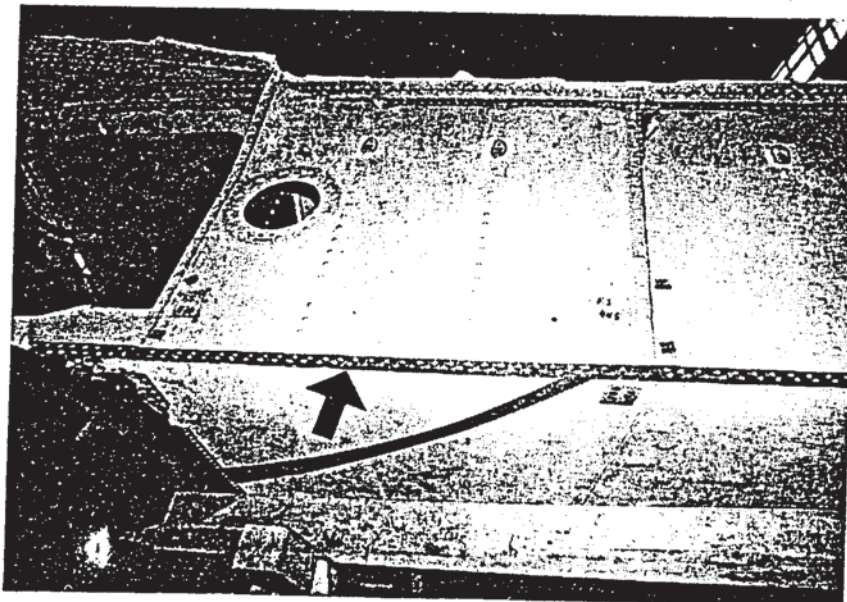
46 Fractured skin at vertical stabilizer forward
torque box front spar right chord

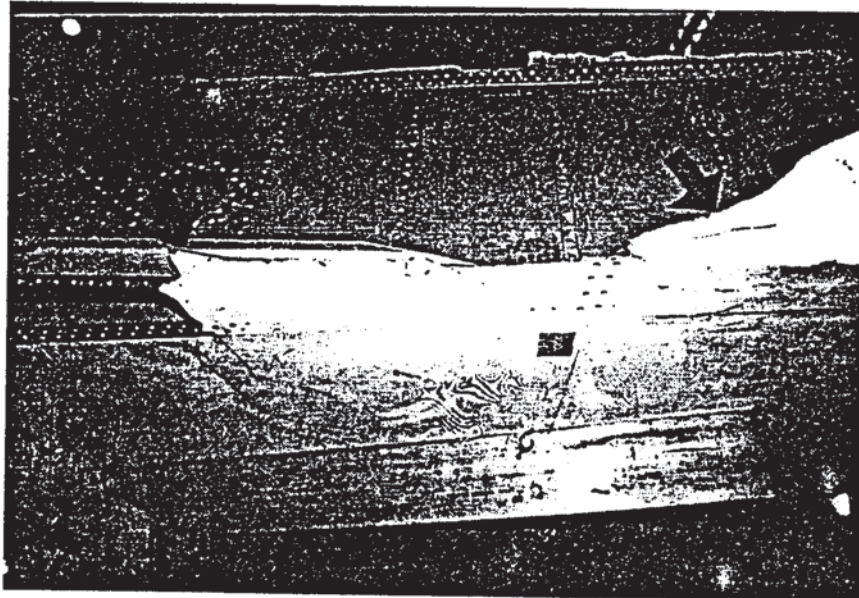
48 Fractured skin at vertical stabilizer forward torque box front spar right chord near FS495

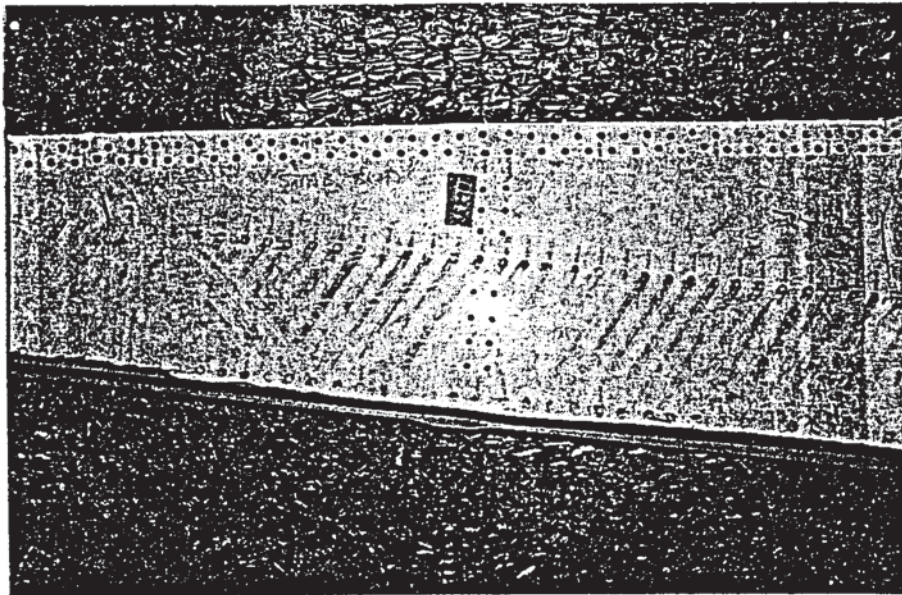
59 Black substance adhering to right side skin of vertical stabilizer (2)

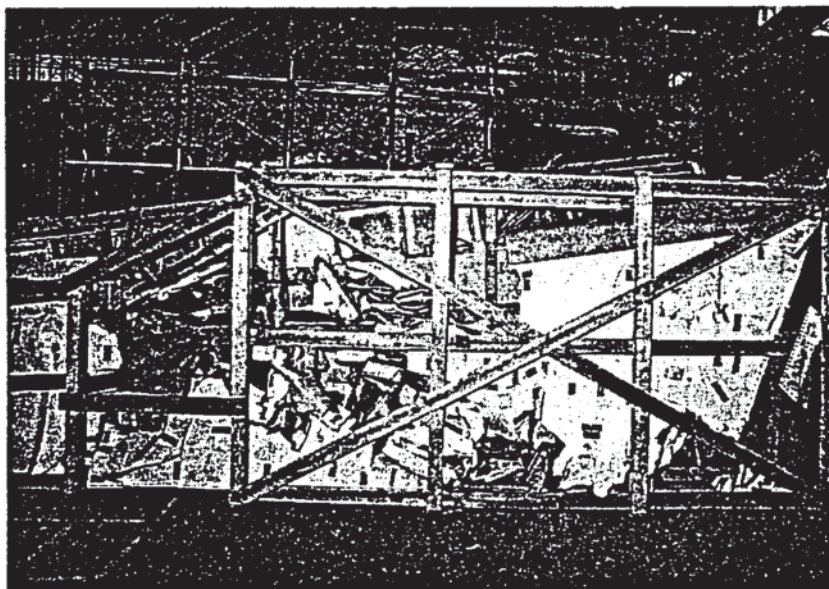
60 Fractured left horizontal stabilizer leading edge

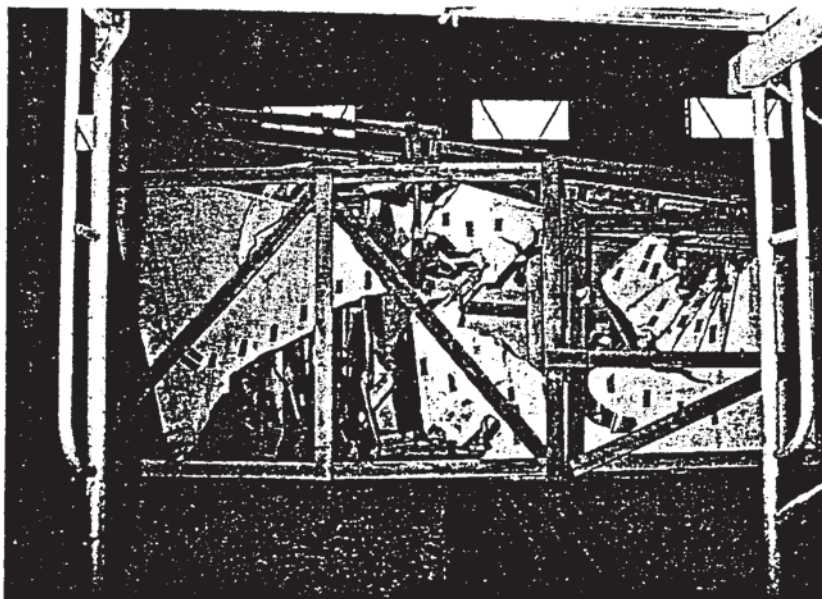
61 Fractured right horizontal stabilizer leading edge

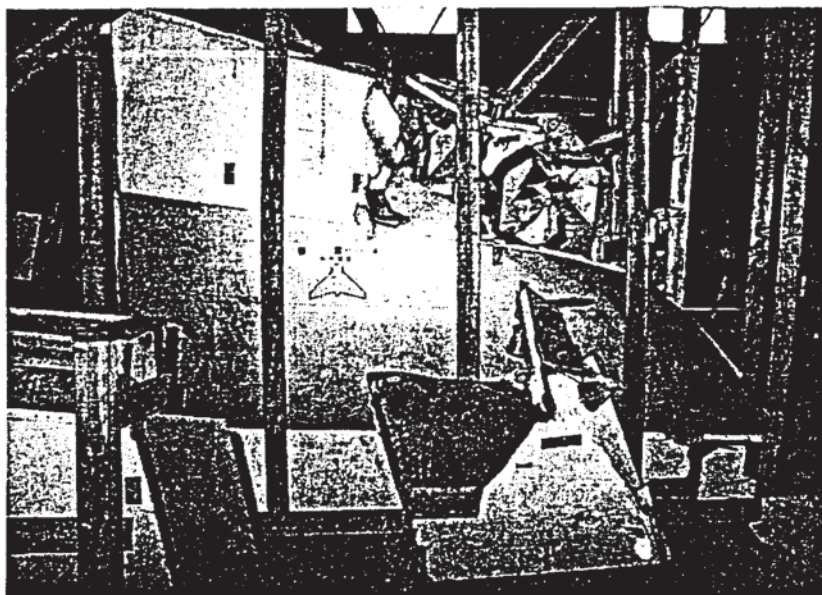
62 Fractured right horizontal stabilizer tip

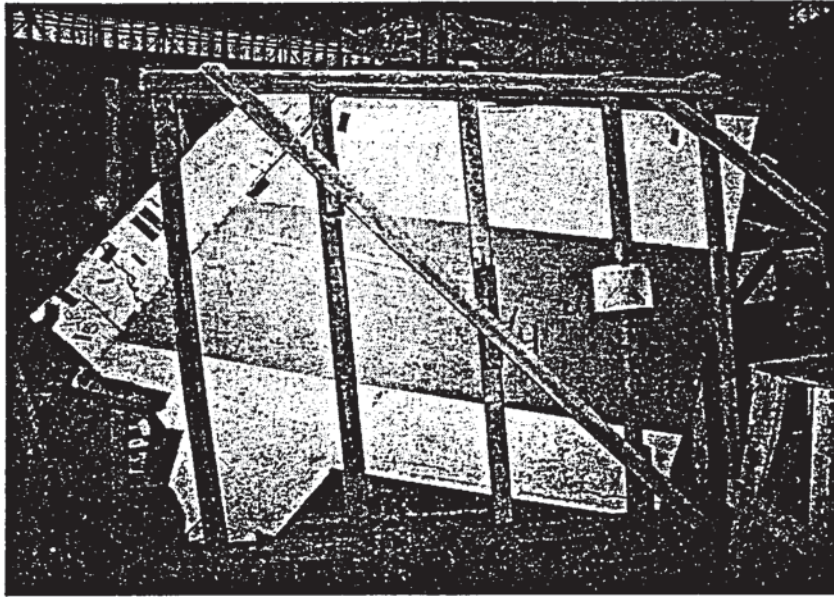
63 Fractured left horizontal stabilizer tip

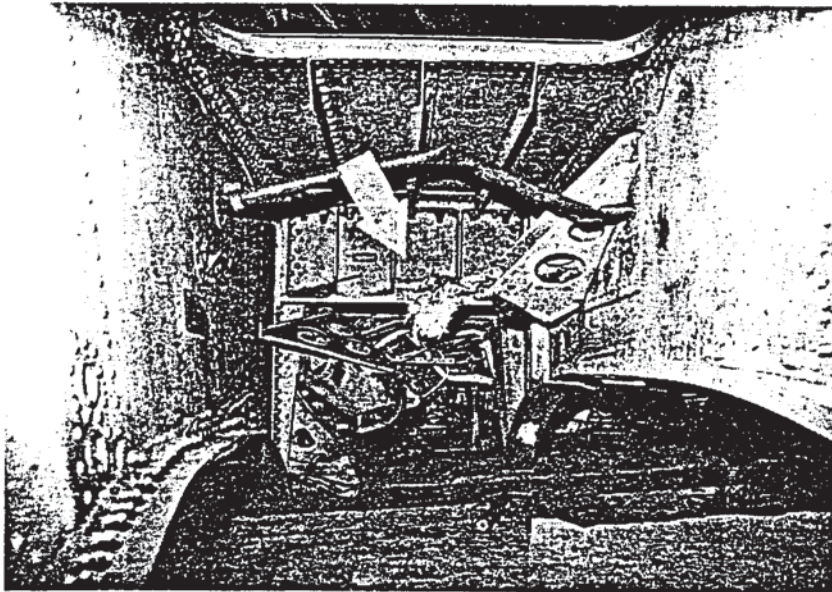
- 94 Fuselage frame at fuselage to vertical fin joint
(BS2436-2460)

Clump of head insulation materials found
reinforcement beam in fuselage frame.

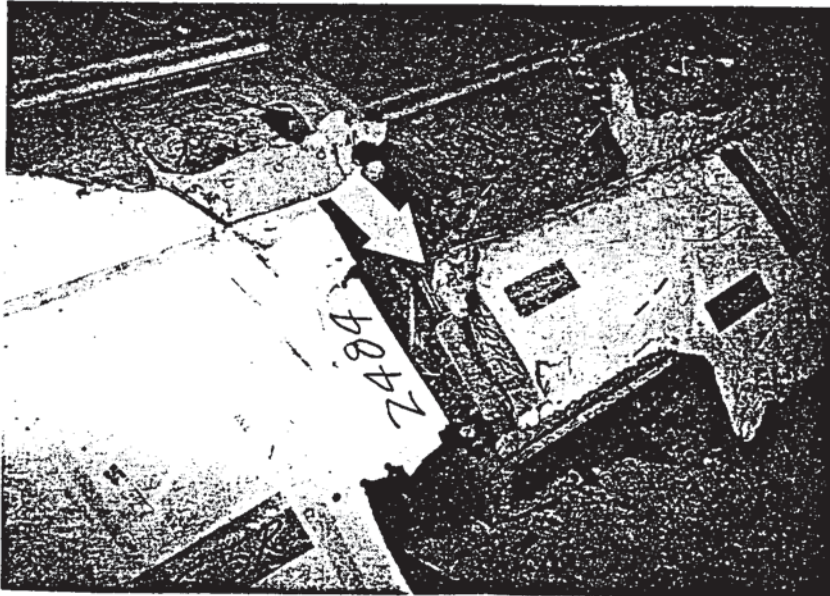
- 95 Fuselage rupture at fuselage to vertical fin joint
(BS2484)

Heat insulation materials found in right skin corner at base of aft torque box.

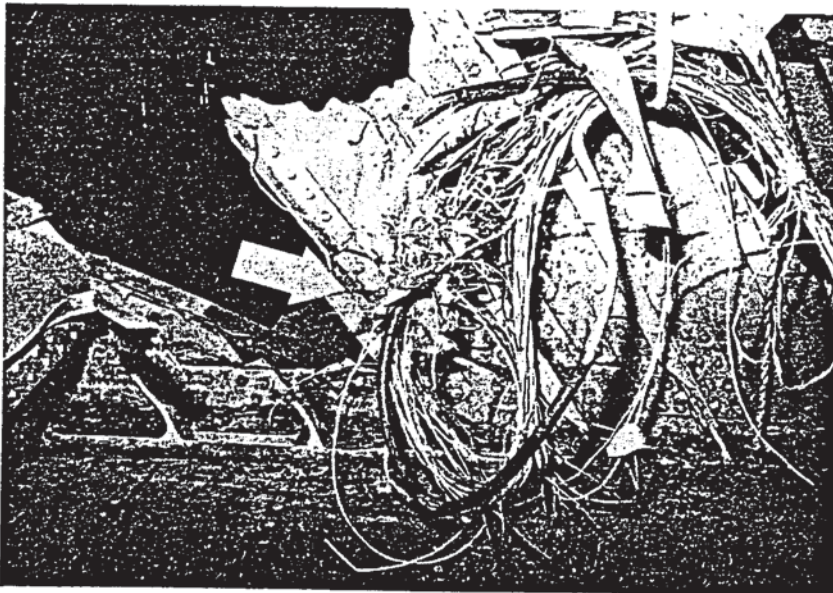
- 96 Vertical stabilizer aft torque box-root of skin on
left side

Film covering heat insulation materials found
tangled in antenna cable, etc.

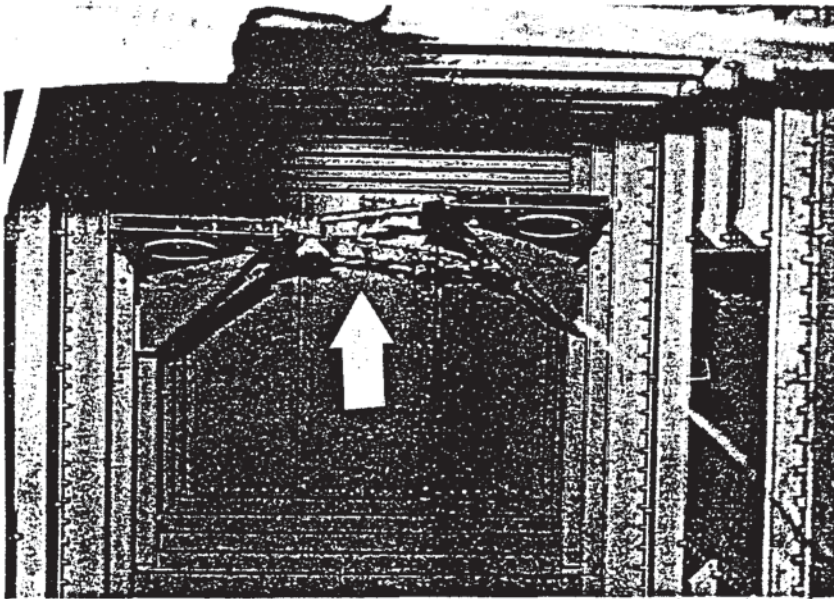
97 Central part of horizontal stabilizer center section

Heat insulation found adhering to control cable inside.

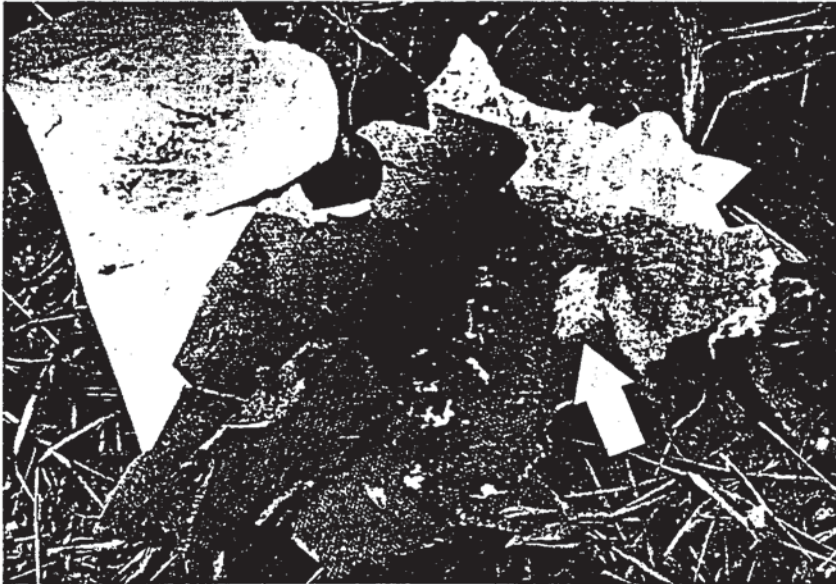
98 Insulation materials adhering to fragments of ceiling of rearmost cabin lavatory (lavatory R)

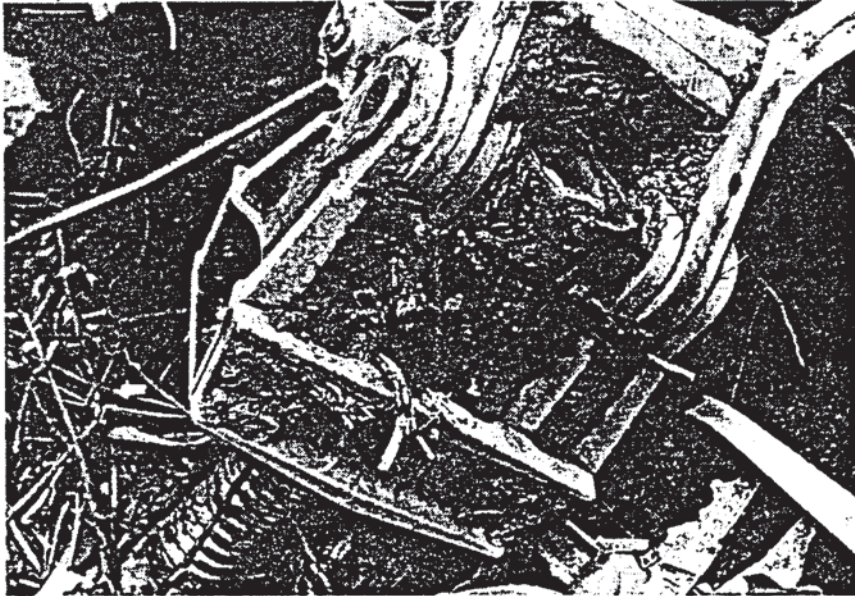
99 Fracture of horizontal stabilizer jack screw (crash site)

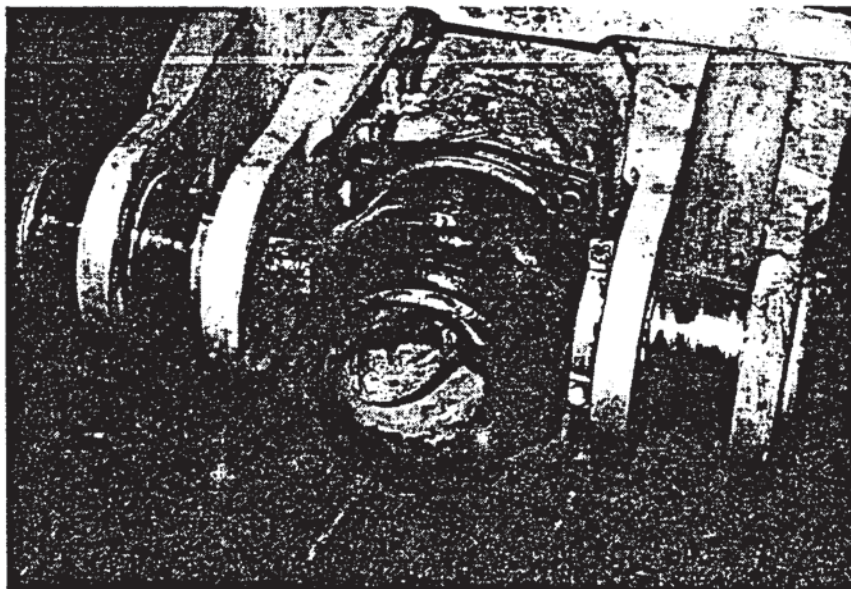
100 Fracture of horizontal stabilizer jack screw
(condition before teardown).

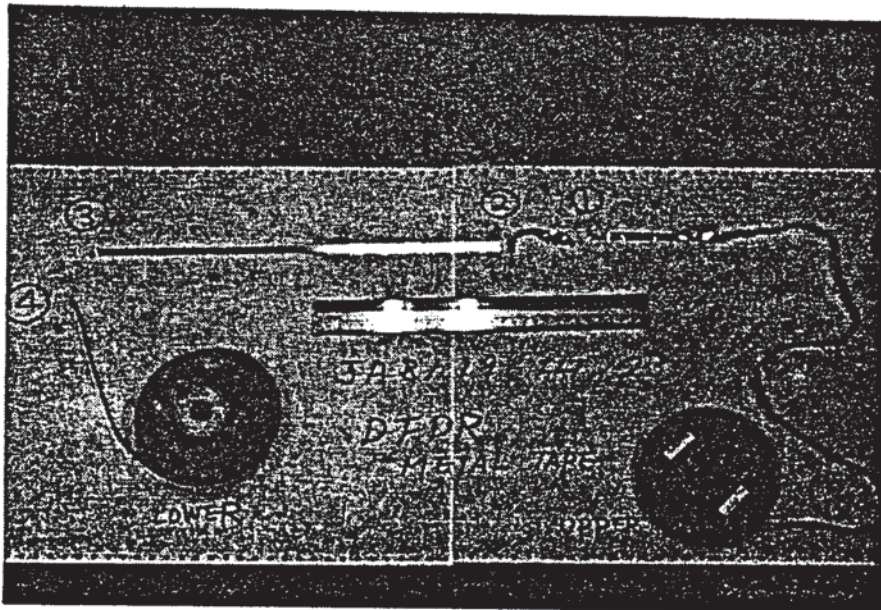
101 Damage to magnetic tape

写真の中の③④は当該飛行以外の記録部分の損傷であり、
また、テープが白くなっている箇所はフラッシュ・ライト
のためである。

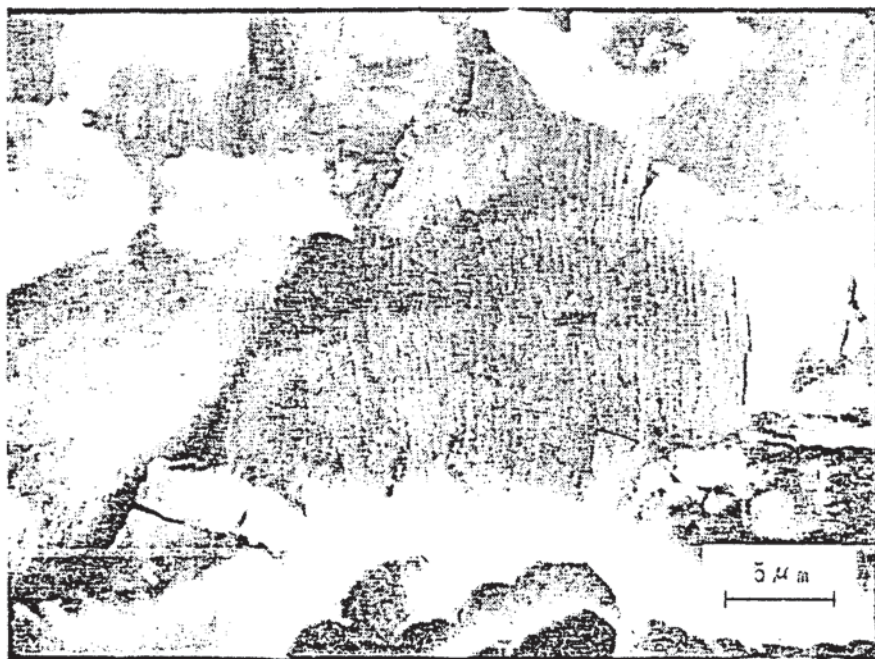
Photo-109 Fracture surface of rivet hole No.34 inboard. Typical fatigue fracture facet. Fine striation patterns show stable crack propagation due to cyclic loading. The spacing of the striation gives the rate of propagation being $0.23\mu\text{m}$ per cycle at this point, 0.28mm from hole edge. Crack grew from left to right on the photo.

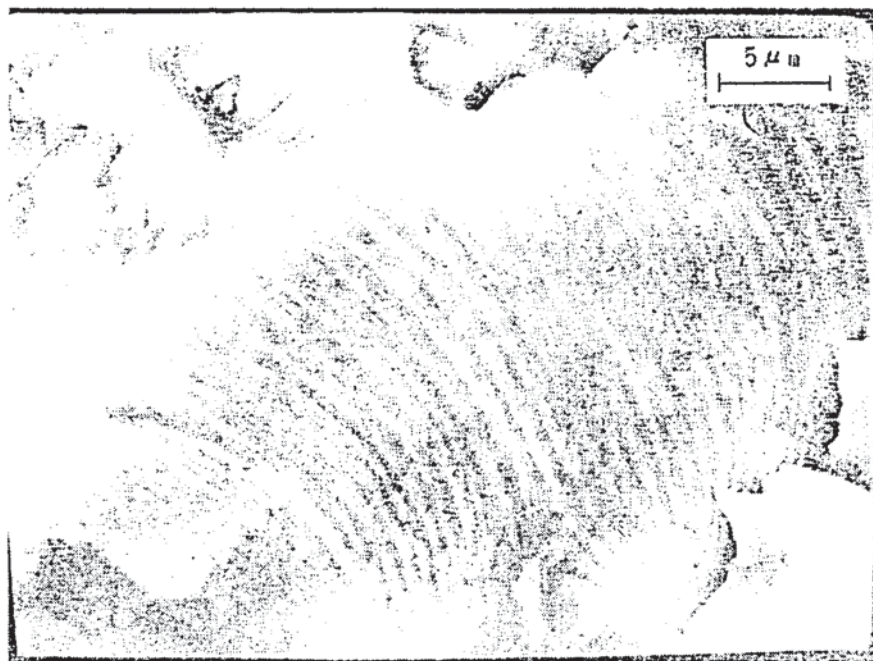
Photo-110 Fracture surface of rivet hole No.34 inboard. Striation spacing increases as crack growth rate increases, at 3.05mm from hole edge near the transition point shown photo-107.

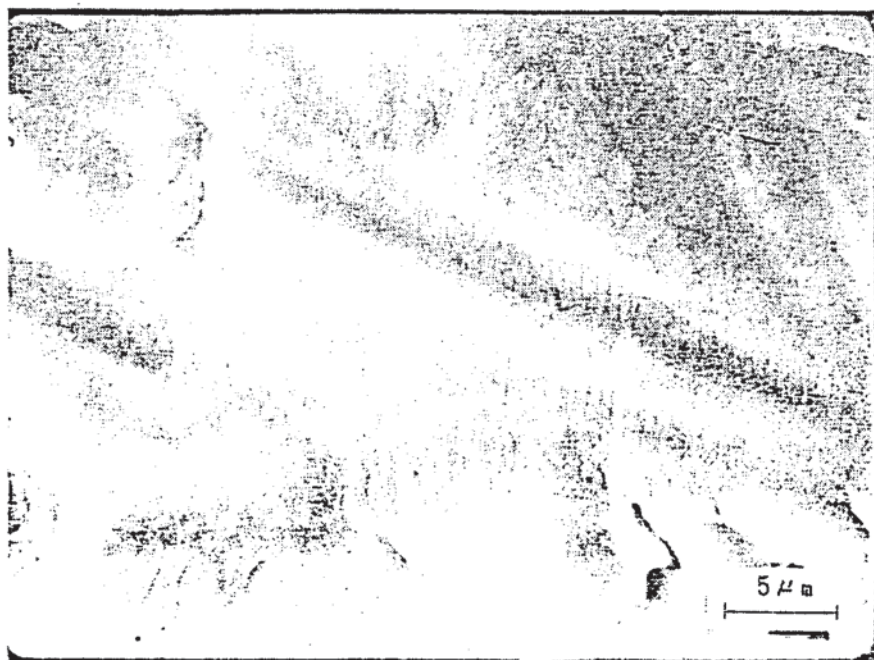
Photo-111 Fracture surface of rivet hole No.47 outboard. Fine striations observed at 0.32mm from egde of rivet hole No.47 outboard. Crack grew from right to left on the photo.

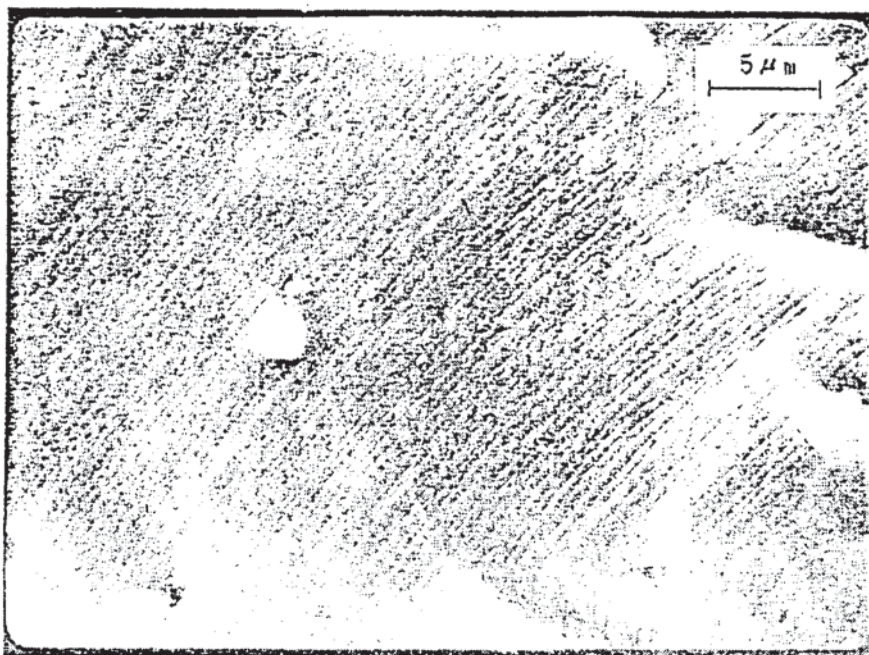
Photo-112 Fracture surface of rivet hole No.53 outboard. Clear striations observed at 1.00mm from egde of rivet hole No.53 outboard. Direction of crack growth is from lower right to upper left on the photo, as a result of local bending load.

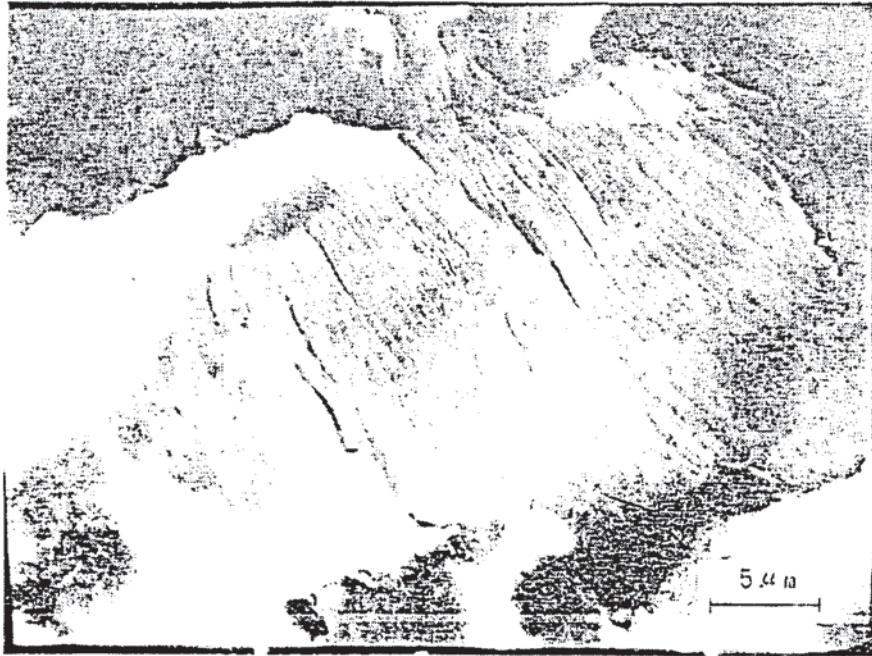
Photo-113 Fracture surface of rivet hole No.66 outboard. Direction of crack growth is from upper right to lower left on the photo at 0.80mm from edge of rivet hole No.66 outboard.

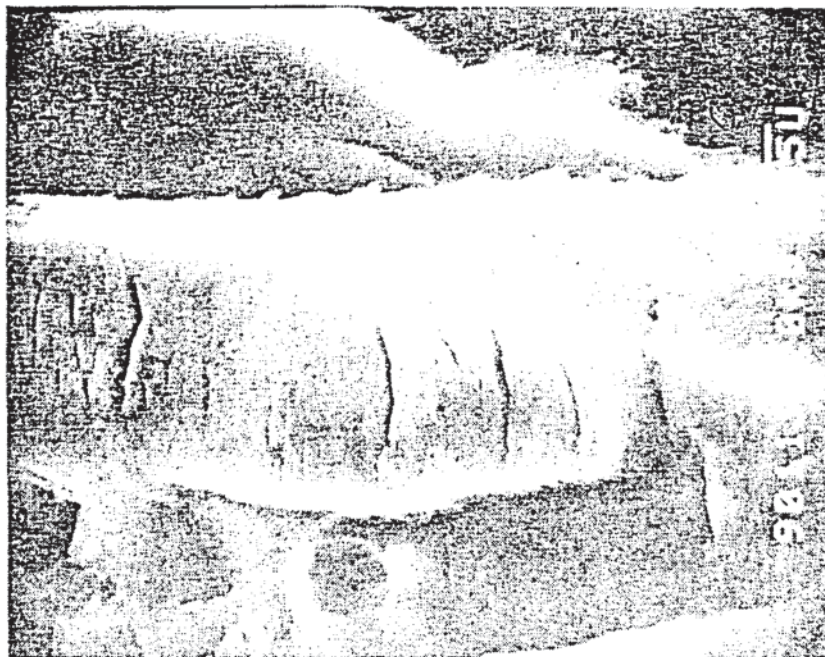
Photo-114 Fracture surface of rivet hole No.90 inboard. Direction of crack growth is from left to right on the photo at 2.60mm from edge of rivet hole No.90 inboard.

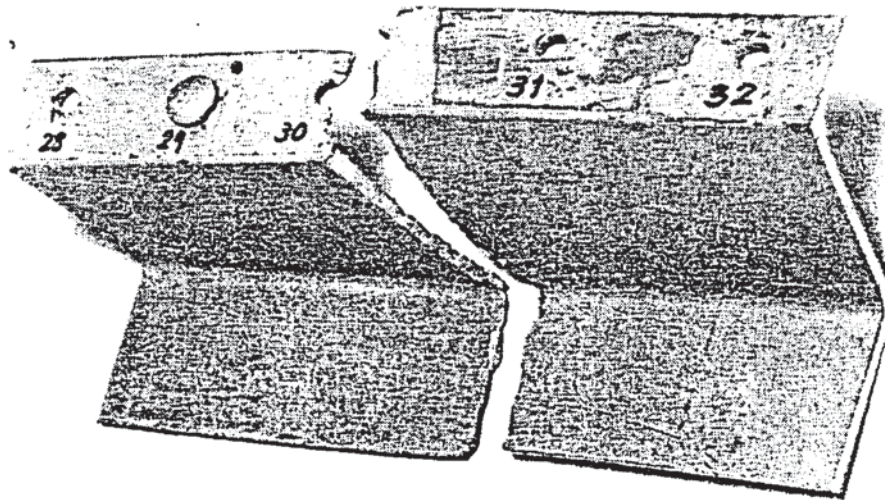
Photo-119 Fracture aspect of stiffener L18, at rivet hole No.30.

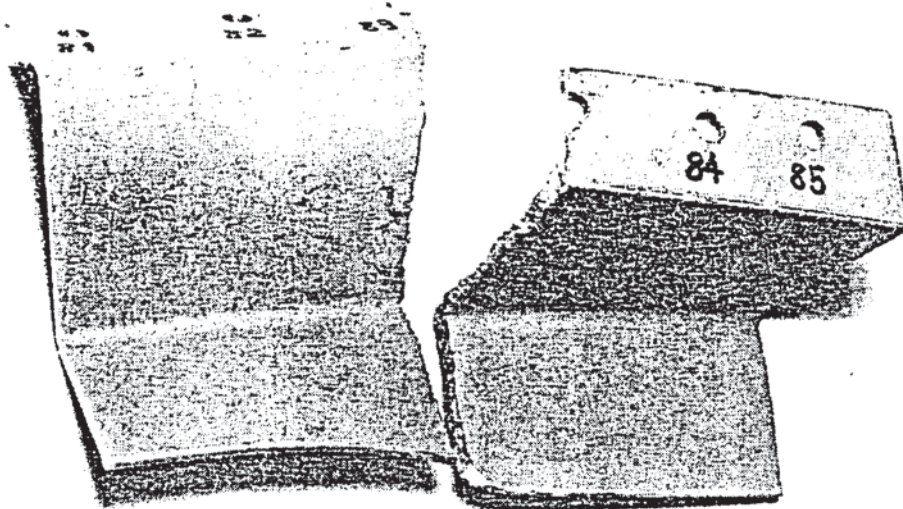
Photo-120 Fracture aspect of stiffener L18, at rivet hole No.83.

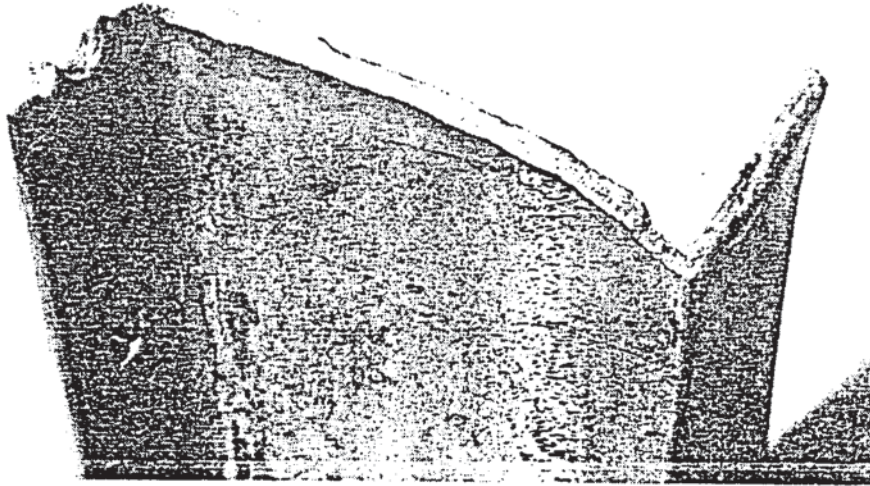
Photo-121 Close-up view of stiffener L18, revealing shear mode fracture, at rivet hole No.30 outboard.

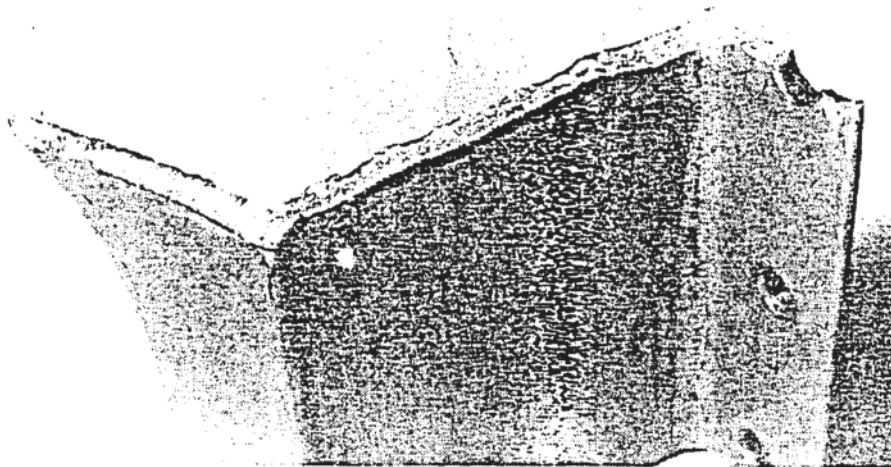
Photo-122 Close-up view of stiffener L18, revealing shear mode fracture, at rivet hole No.83 outboard.
